Measurement of X-Ray Radiation Exposure in Thorax Examinations at Radiology Installation of Wajak Husada General Hospital

Sri Sugiarti^{1,*}, Farida Wahyuni², Dewi Okta Nur Anisa³

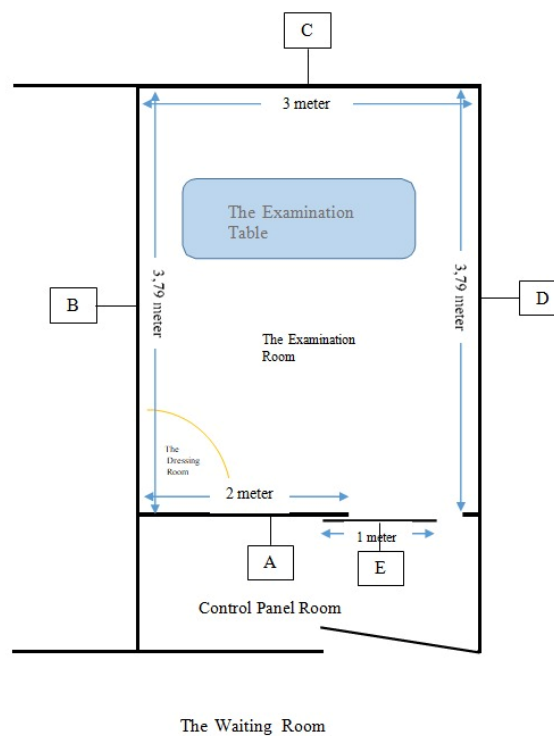
Figure 2. The structural design of radiology installation at Wajak Husada General Hospital

Then, in Bapeten Regulation No. 4 of 2020, the room walls for all types of X-ray aircraft are made of 25 cm red brick or concrete with a 2.2 g/cm³ density. The X-ray room door must be lead-coated with a certain thickness of 20 cm or equivalent to 2 mm of lead (Pb). The walls of the radiology examination room at Wajak Husada Hospital are concrete with a thickness of 20 cm. This requirement has met Bapeten Regulation No. 4 of 2020. The door size is 1 x 2.05 (length x height) m and coated with lead (Pb) according to the standard of Bapeten Regulation No. 4 of 2020. Radiation signs in the Radiology Installation examination room at RSUD Wajak Husada are available on the door and have met the requirements according to Bapeten Regulation No. 4 of 2020. One of the factors that are considered in radiology services is radiation protection.
